HIGHLY ACCELERATED LIFE TEST REPORT #1358

Technologic Systems Single Board Computer – TS-7250

Highly Accelerated Life Test Report

Single Board Computer – TS-7250

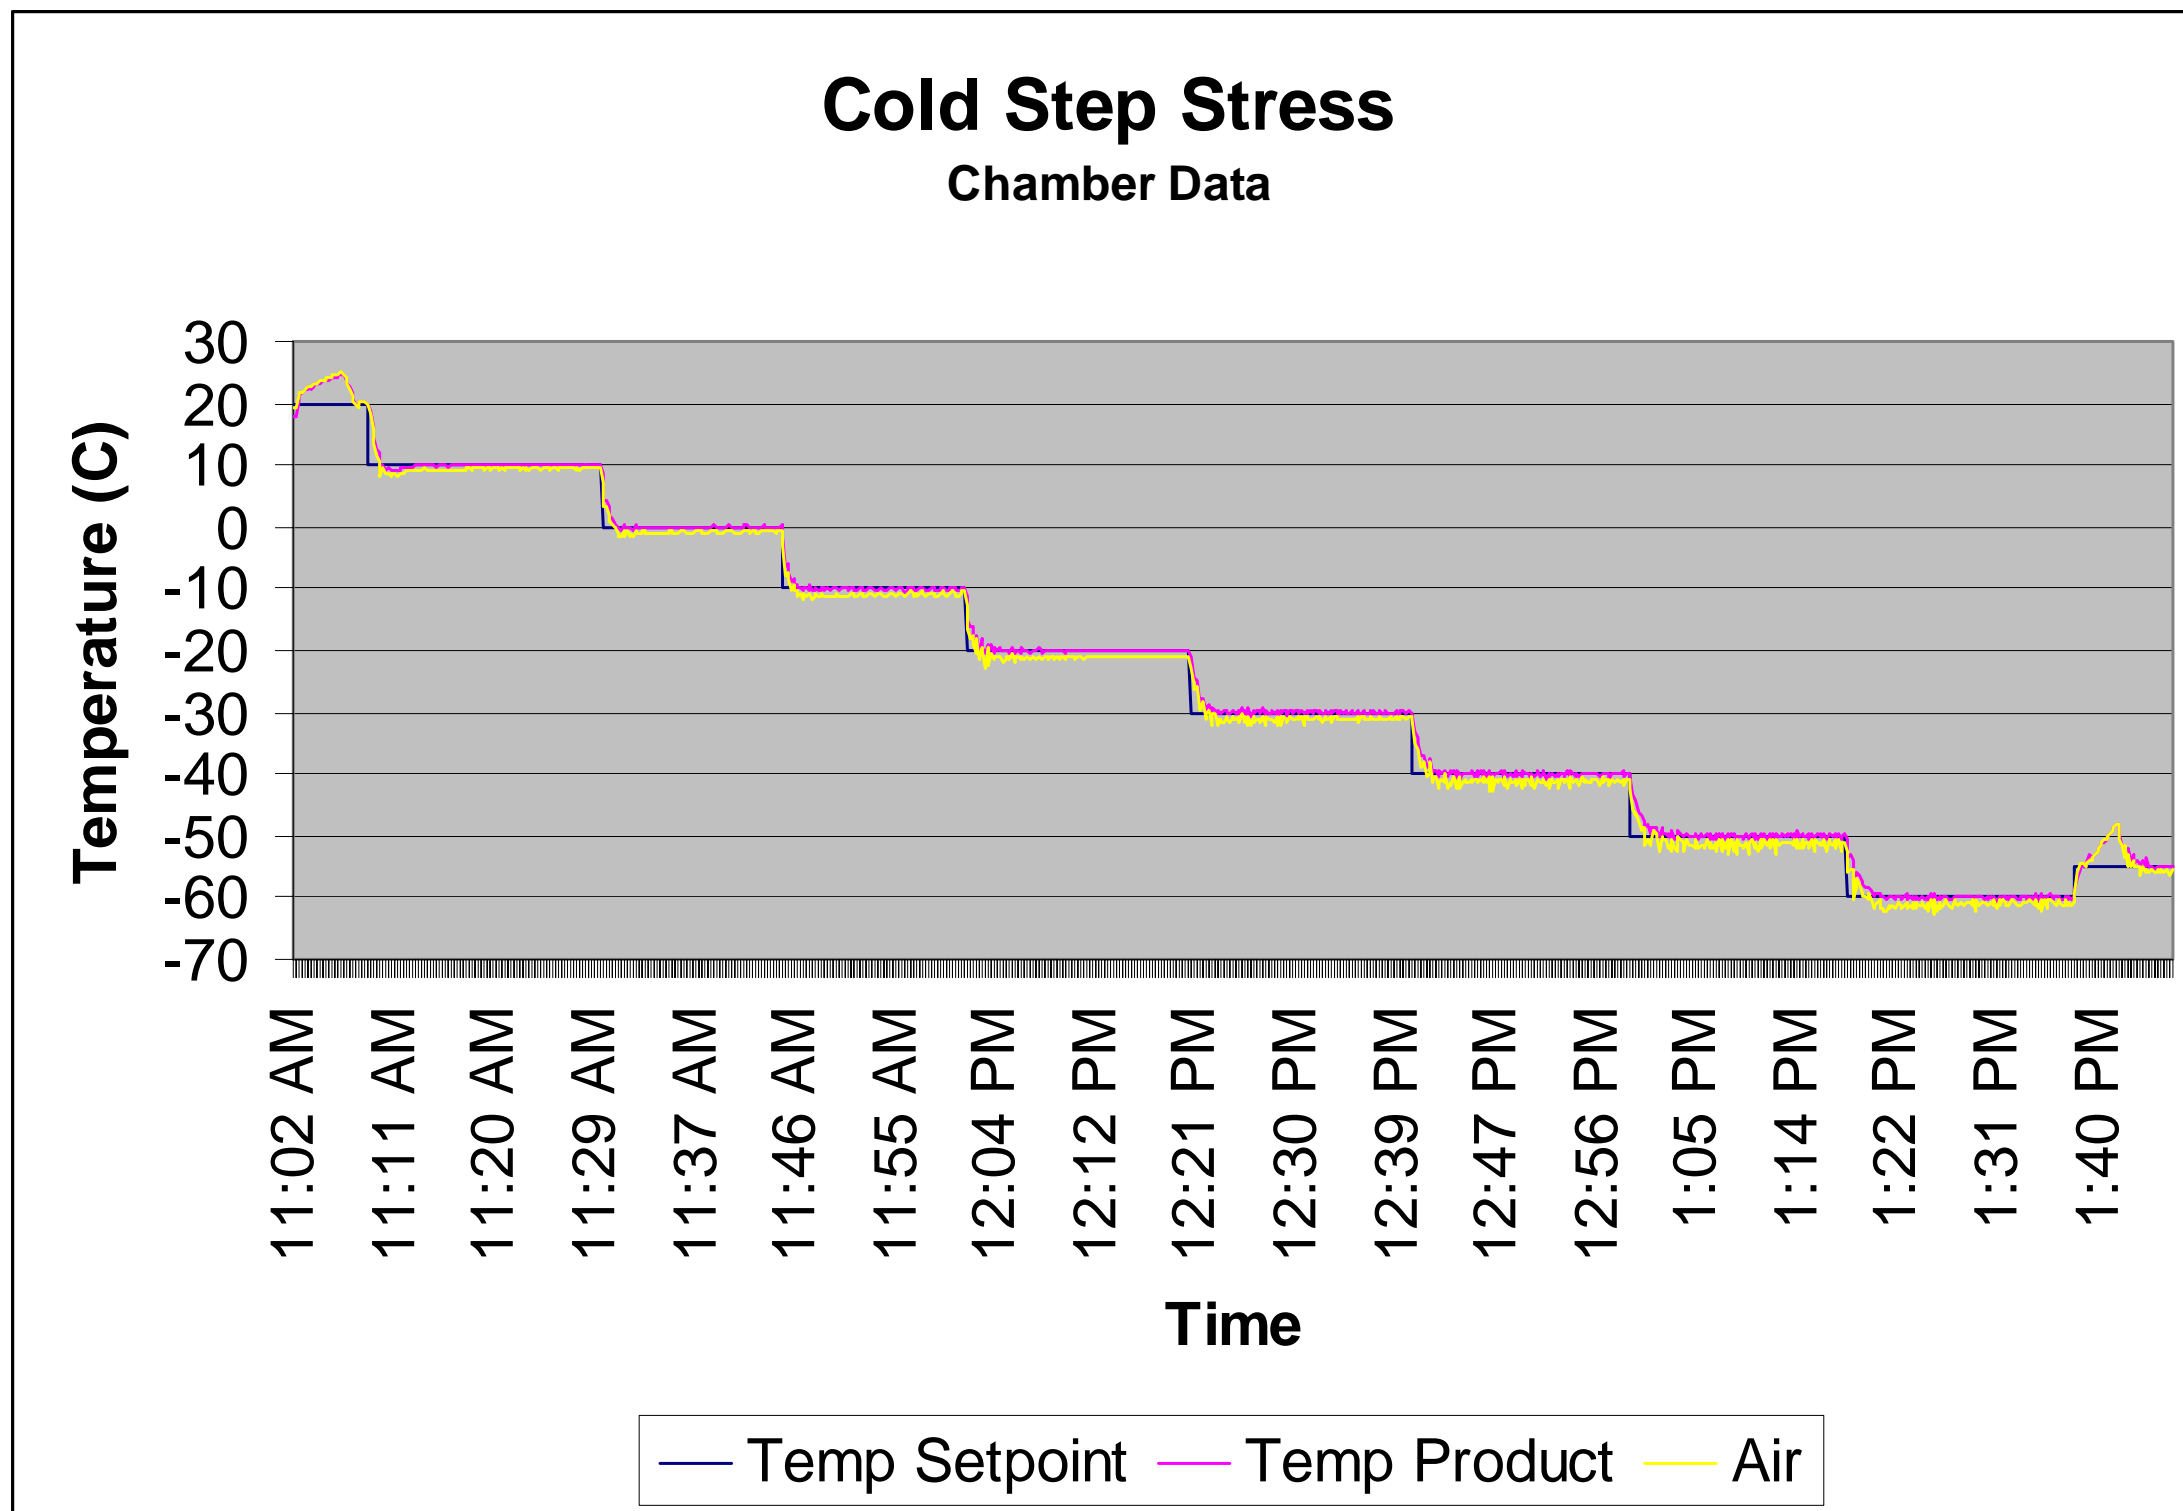
Figure 3: Cold Step Stress Test – Chamber Data

1. At -60°C corrupted data appeared in the flash memory of UUTB, UUTC, and UUTD. The temperature was raised to -55°C, but the problem remained. This is a failure mode that will not recover; once the data is corrupted, it has to be reloaded.

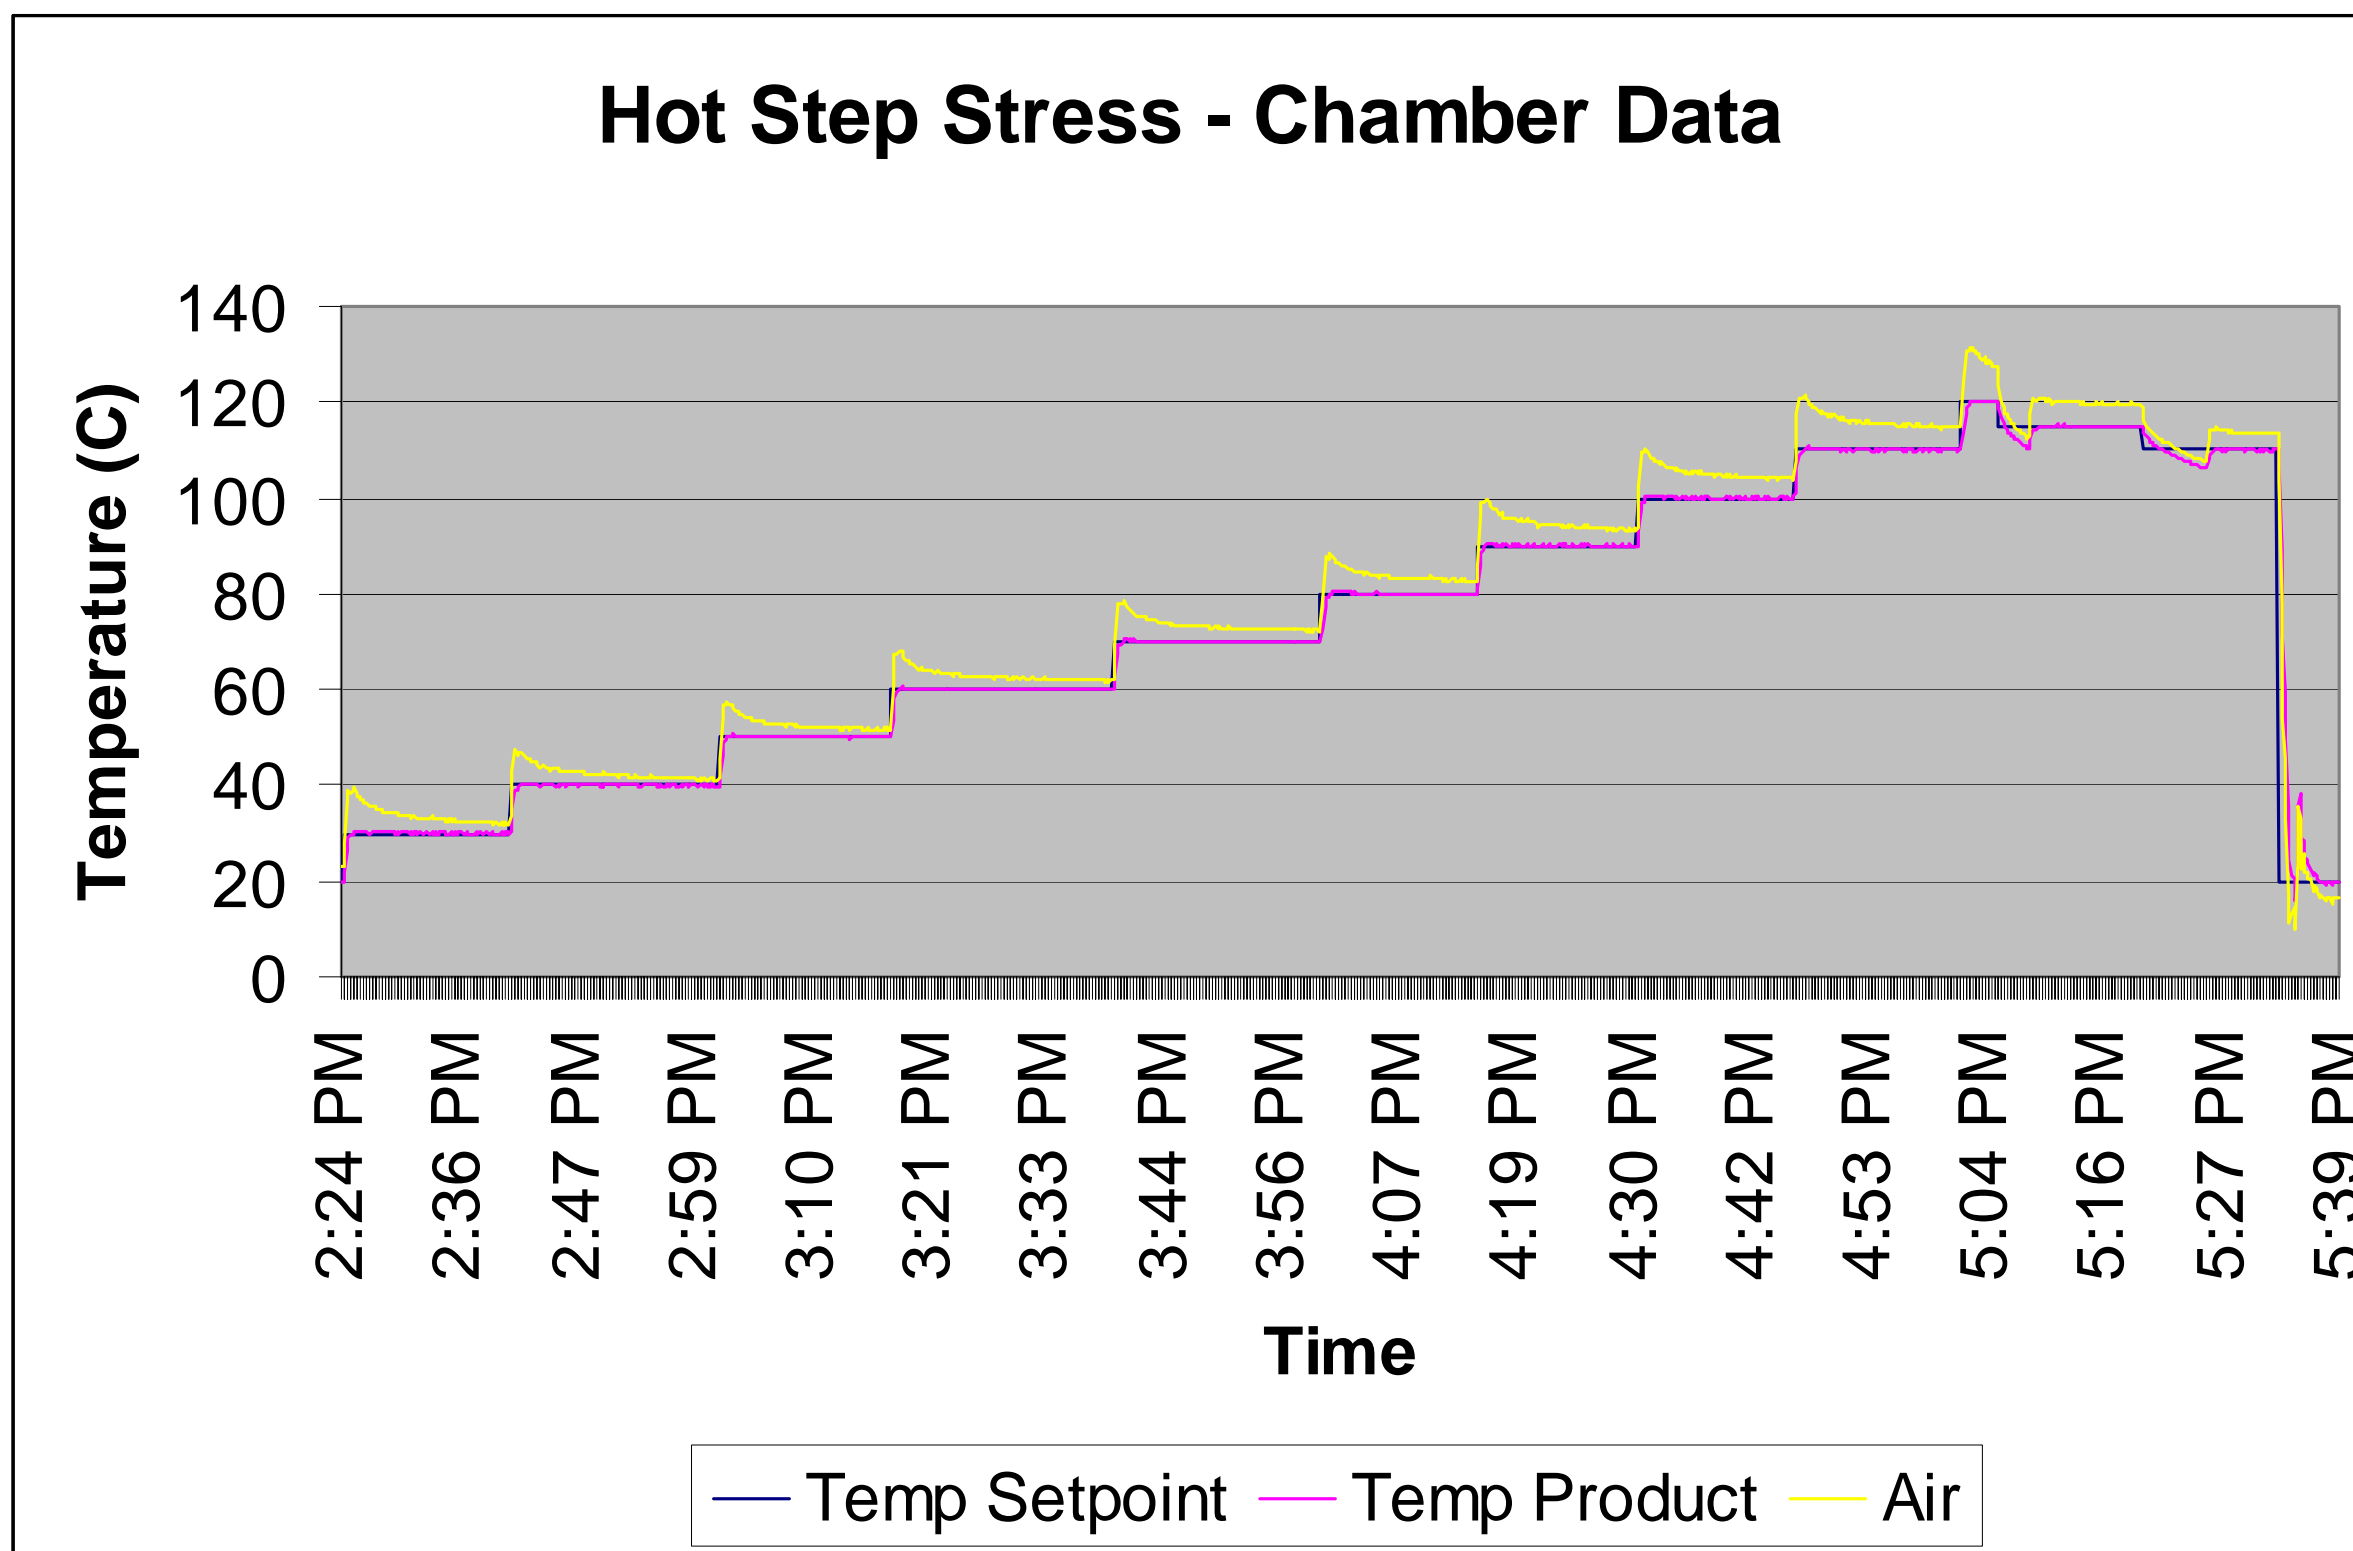
Figure 5: Hot Step Stress Test – Chamber Data

1. At +120°C, both serial and Ethernet communications were lost with all four UUTs. It was noticed at that time that UUTA was automatically rebooting. The other UUTs may have also been rebooting, but it was not noticed. The data logger for UUTB 3.3 VDC shows that is dropped to 0 Volts several times during this period.
2. At +115°C, after recycling the input power, UUTA passed all tests, and at +110°C UUTC and UUTD recovered. UUTB did not recover until the chamber was rapidly dropped from +110°C to +20°C.

b) Hot Step Stress Test – Investigate to determine the cause of the failure to communicate with the UUTs at 120°C. A similar problem was seen during the Combined Environment Test at 110°C.

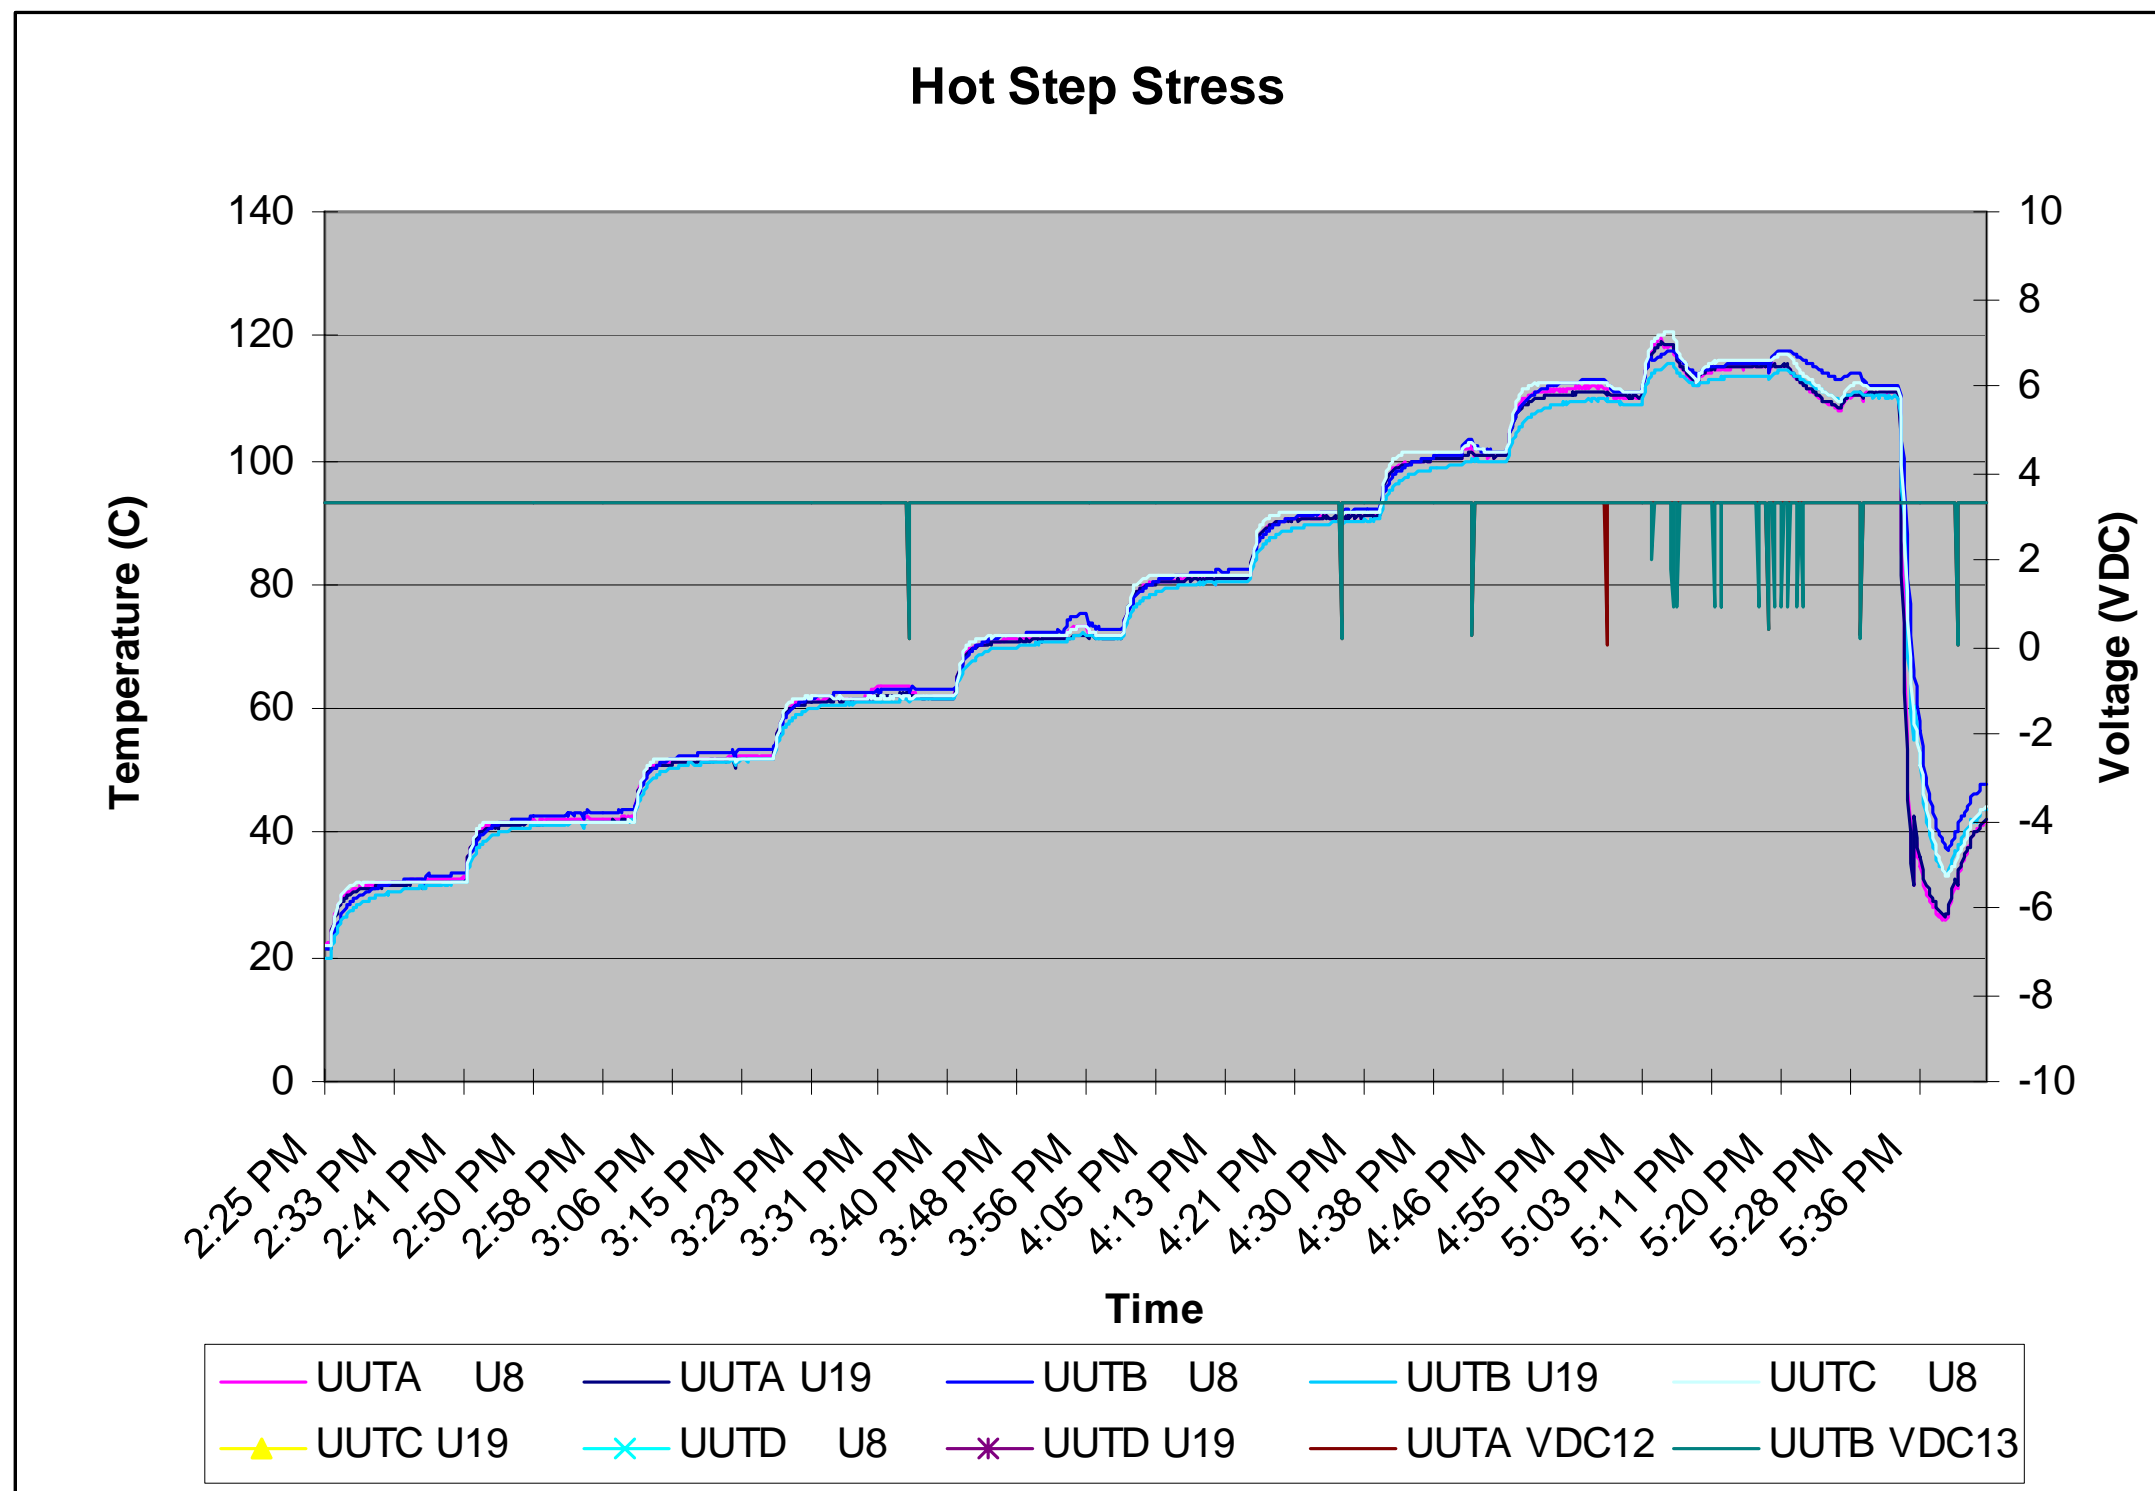
Figure 6: Hot Step Stress Test – Thermocouple and Voltage Readings

+120	Fail	Ethernet & Serial – All boards lost communications. Noticed that Board A rebooted itself. Others may have also. All LEDs lit, but Ethernet LED is blinking on UUTC & UUTD, but no packets are being sent.
+115	Fail	Receiving garbage data on COM port; rebooted All – Serial - Good (A); Ethernet – Good (A). BCD still no communication.
+110	Fail	Power Cycle – ACD good, B no communication, but 3.3 VDC good; DIO – ACD good, COM - ACD good; USB – ACD good, Ethernet – ACD good, B bad; Flash – ACD good,
+20	Pass	After rebooting, all UUTs appear normal.

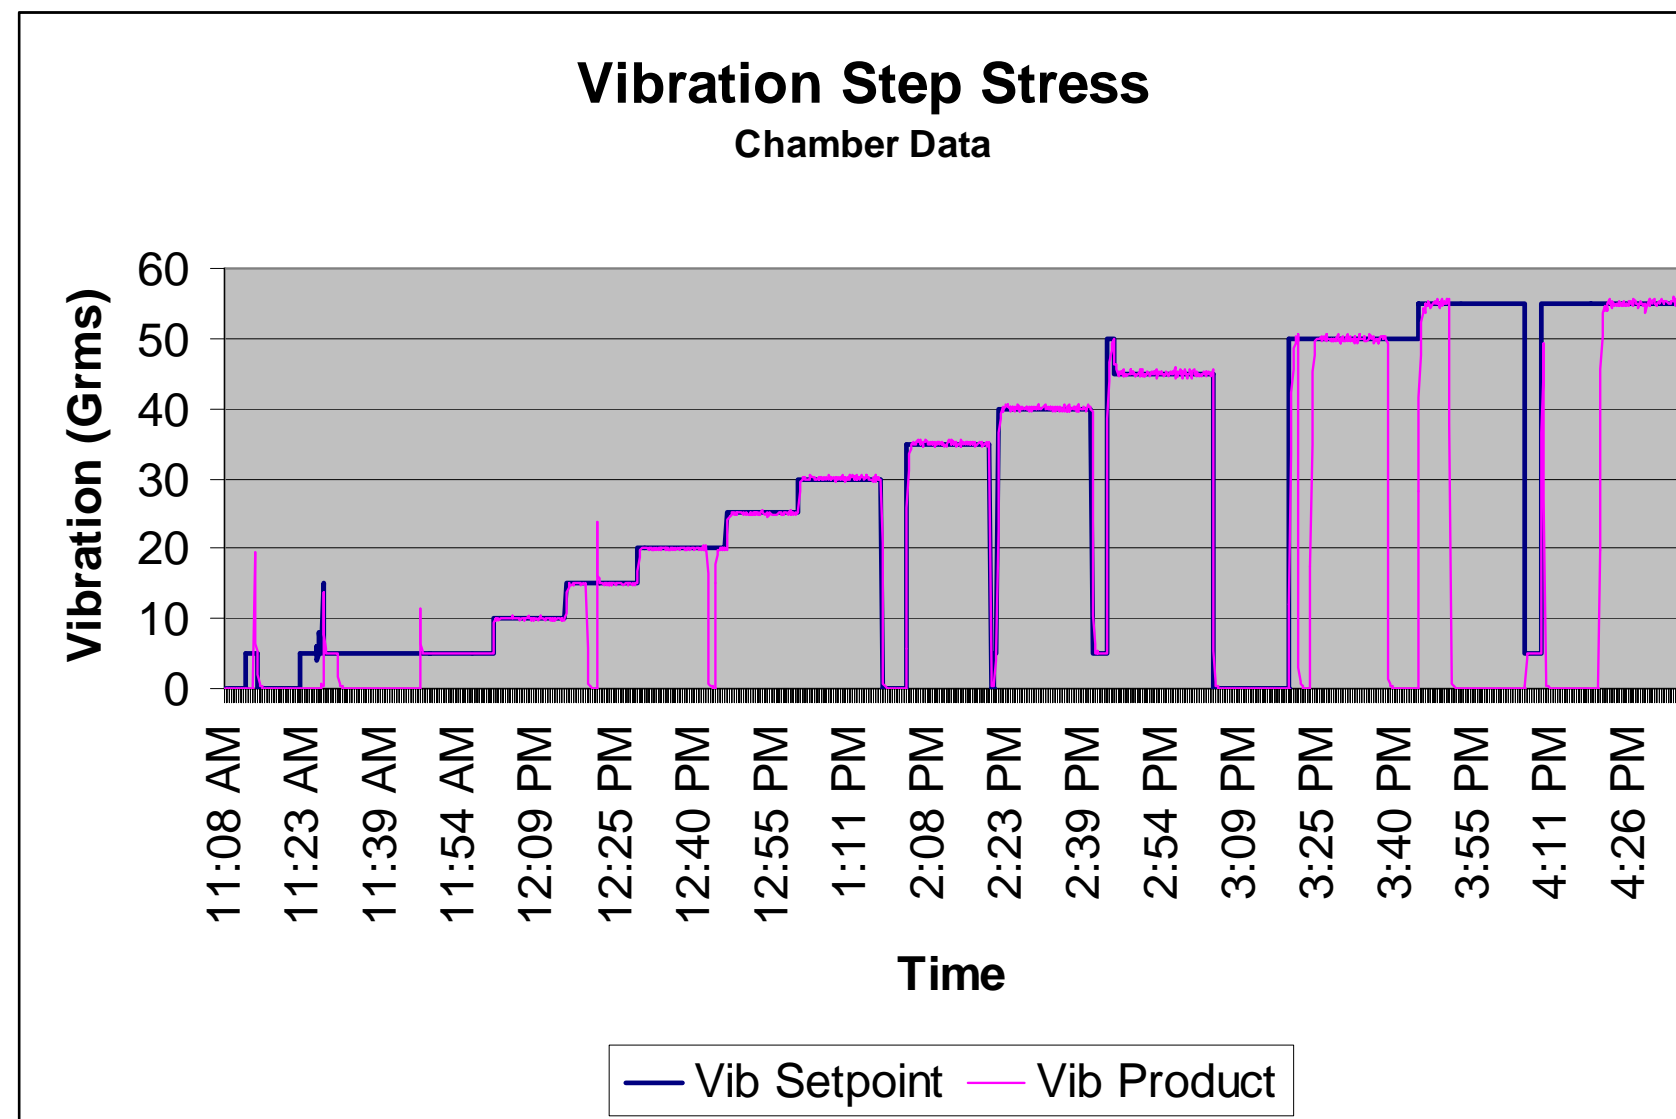
Figure 9: Vibration Step Stress Test – Chamber Values

1. At 10 Grms and 20 Grms, there were some cases in which the UUTs would reboot by themselves. This may have been due to the vibration affecting the power supply connector at the PCB. (Combined Environment Testing on Day 3 used a soldered power connection to the UUT in lieu of the power connector. See results in paragraph 9.6.)
2. At 30 Grms and higher, failures were seen related to USB communication.
3. At 40 Grms and higher, UUTs started rebooting by themselves. Also saw one instance of the Ethernet test failing.

d) Vibration Step Stress Test – Investigate the USB connection/interface to confirm the assumption that the USB test failures were due to that interface.

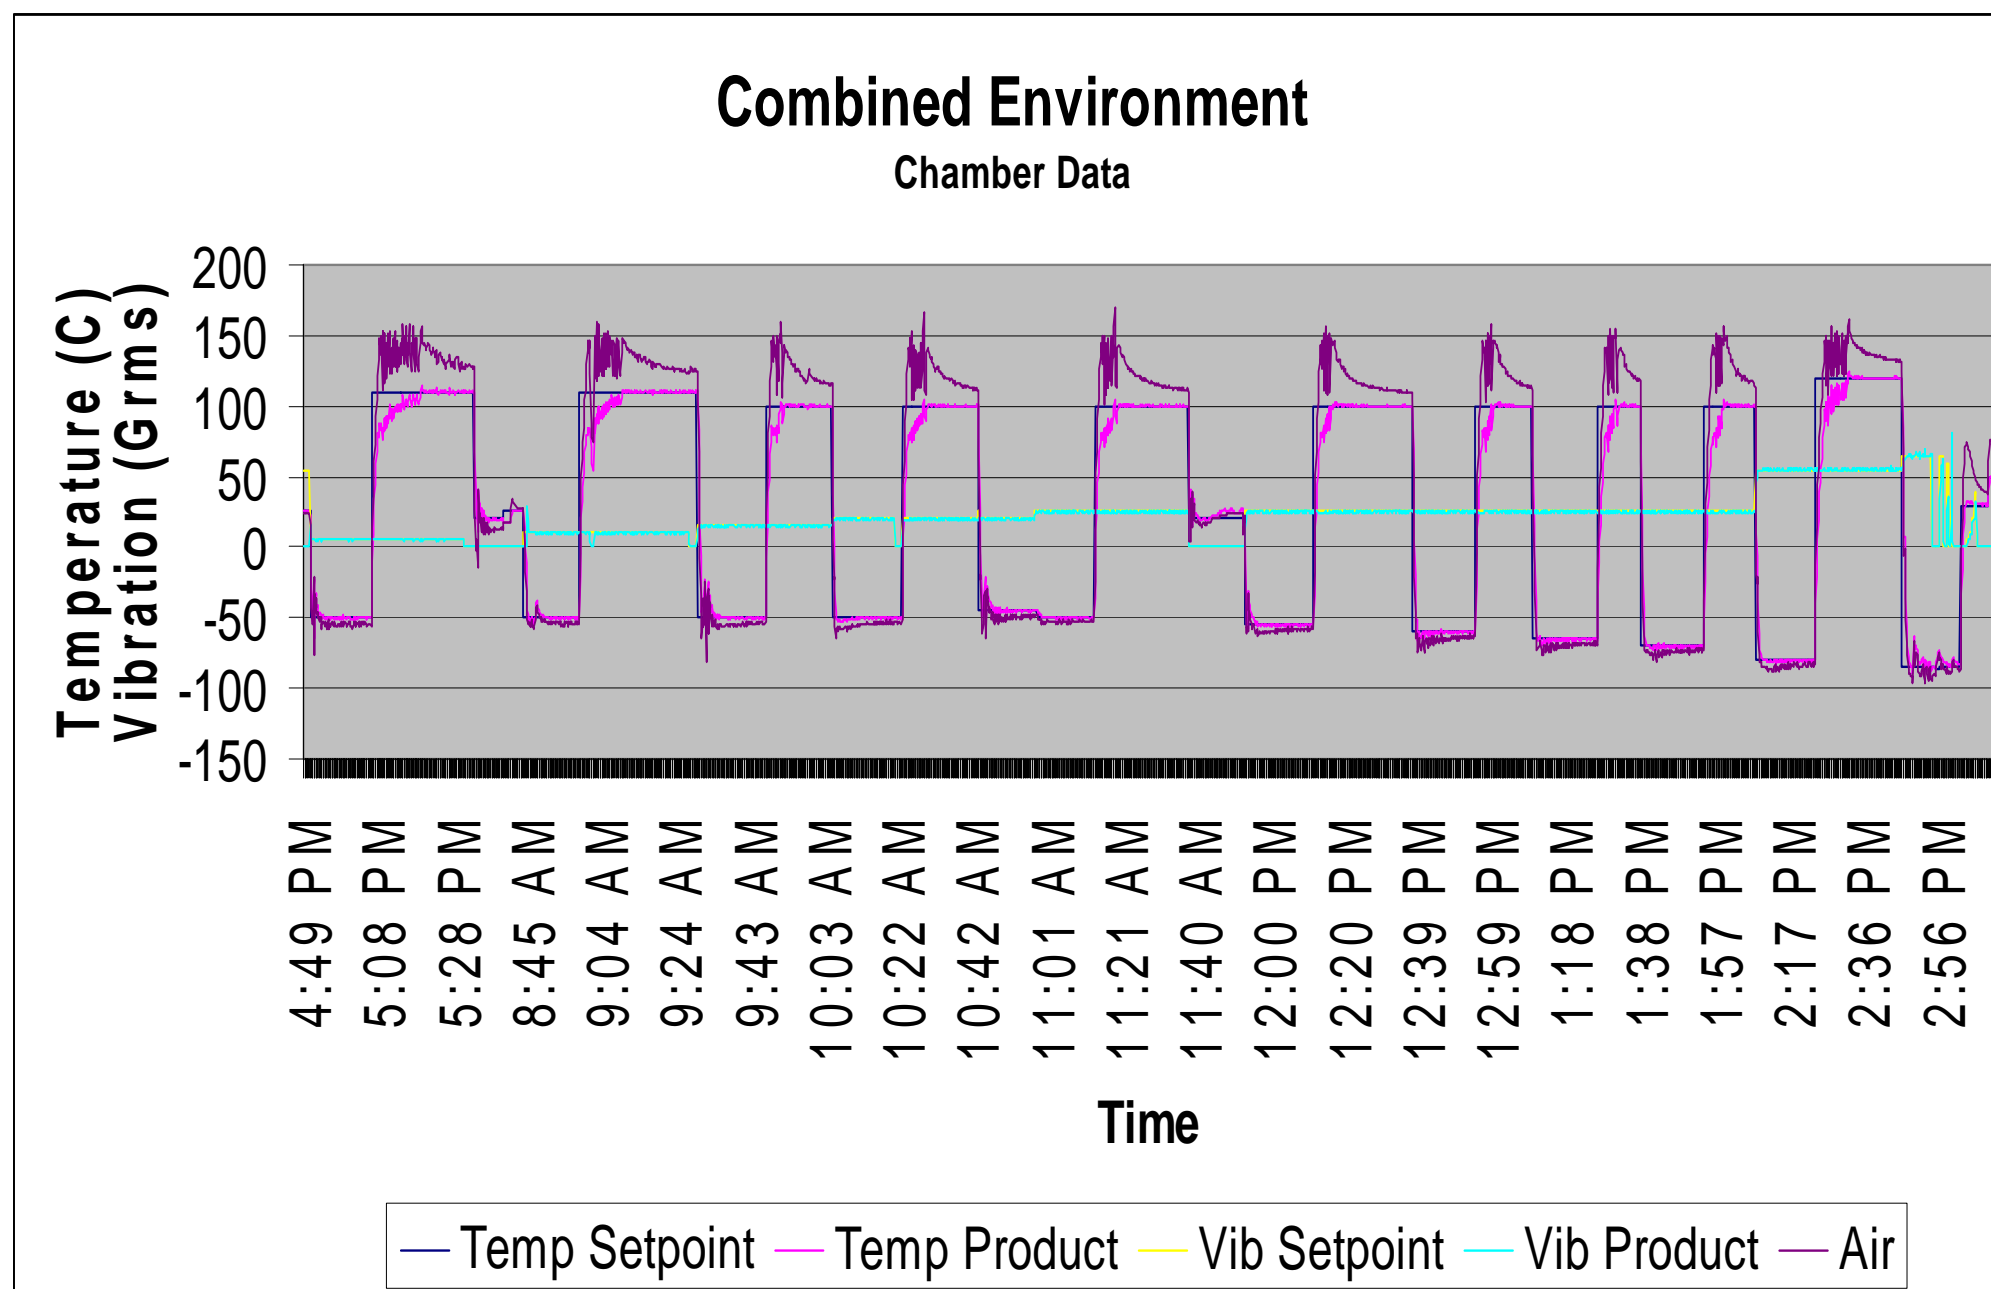
Figure 10: Combined Environment Test – Chamber Data

2. During the first two cycles, the upper temperature limit was +110°C - but at that level there were numerous problems attempting to communicate with the UUTs. When the temperature was dropped back to +100°C, communication was reestablished. Root cause of this problem needs to be investigated.

e) Combined Environment Test – Investigate the cause of the dim Green LED during the testing at -85°C and 65 Grms (very extreme levels).
